Internal erosion or (fast) liquefaction? Some interesting dyke failures

¹Emőke Imre, ²Daniel Barreto

Keywords: dyke, liquefaction, piping, failure, flood protection dam

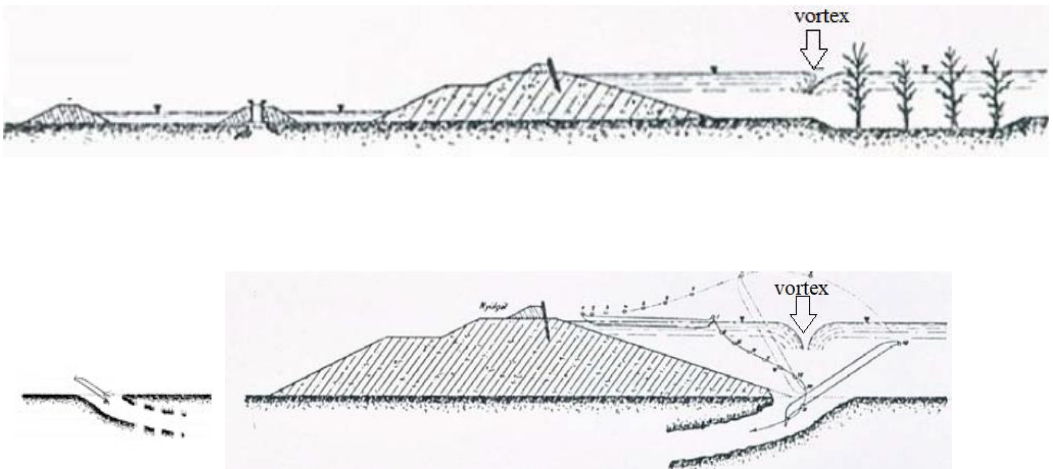
the same time, a boat/canoe about 10 m long and 2 m wide was put on standby. Two days before the breach, the water level in the counterpressure basin started to oscillate, indicating pipe formation. Therefore, preventive materials (boat to sink if needed, piles, sand bags, piles, etc) were prepared. The breach happened within minutes, and a mud geyser appeared at the location of the sand boil. Seeing this, the chief engineer immediately ran up to the embankment crest and glanced at a vortex about 30 m from there, which was constantly approaching the embankment. When it approached the levee at 15-20 m, the boat began to tilt into the vortex, its nose up, dived under the dike, and reached the other side of the dike (see [1]) due to a kind of sink-hole effect. Subsequently, the crest began to crack, the embankment settled 8-10 m, the water began to flow into the saved area, and the breach widened to about 100 m. The depth of the washout at the rupture site was 24 m below the level of the flood.

Figure 1. Illustration of the boat diving to the pipe, (a) condition some minutes before breach, (b) the path of the boat, which ended on the land side at around the first sand-boil spot. (after [1])

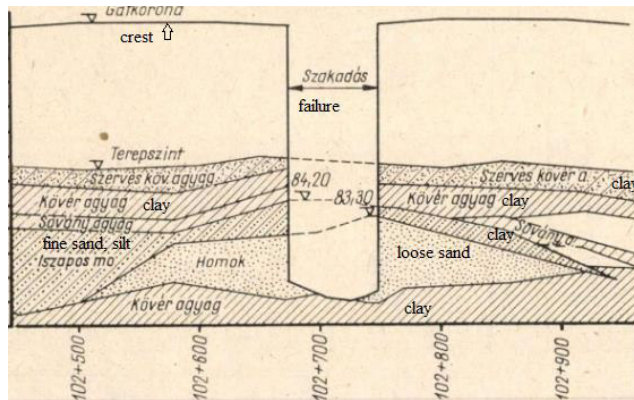
Figure 2. Kettős Körös river, Hosszúfok in 1980, loose, thick sand layer prone to liquefaction [3].

The evaluation: the piping mechanism is possibly liquefaction of the extremely loose and thick sand lens at the thickest dimension of the layer (Fig. 2). The cause was assumed to be a dynamic effect caused by liquefaction. The possible dynamic effect was the tearing off the very plastic clay cover layer (typical for this part of Hungary) at the first geyser spot (Fig. 2) and the sudden displacement of the dyke body due to the increased horizontal load.

In these three reported cases, failure may be attributed to regressive erosion and/or concentrated leak erosion (while contact erosion is not possible according to existing filter criteria). It is, however, more likely that static or dynamic liquefaction occurred. This is supported by the occurrence of sand boils, the formation of geysers from below a plastic clay surface layer after being torn off suddenly, and the loose state of the deposit of silty sand in Hosszúfok (Fig. 2). With similar observations, the

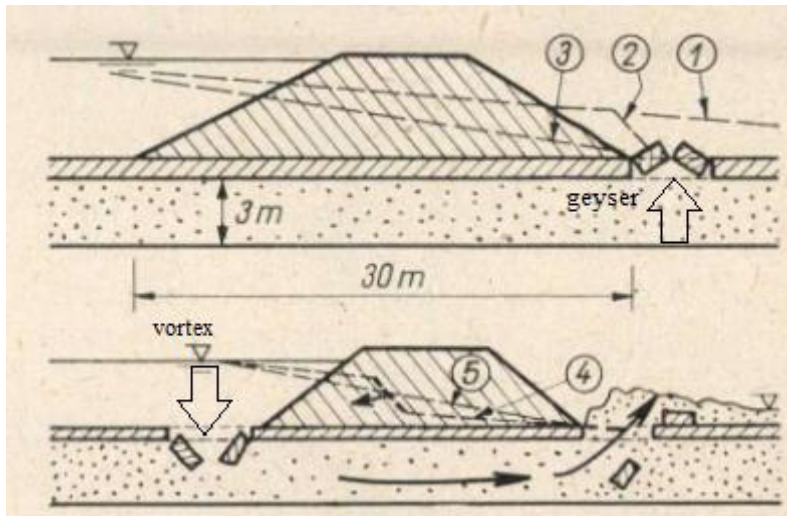
Figure 3. The hypothesis of fast, liquefaction piping in [3] completed by the vortex.
